Aquatic Invasive Species Management Report

Upper Saranac Lake September 3-6, 2019

INVASIVE SOLUTIONS

DIVE COMPANY, LLC

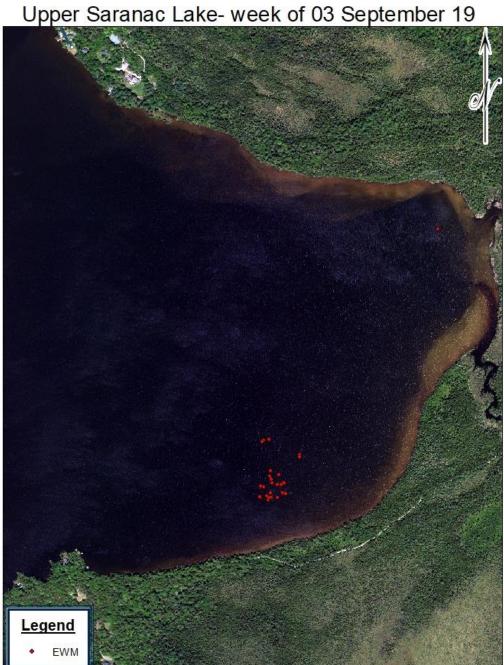
Site 5- North Basin

Description: Crew began the day responding to a lake manager buoy in northeast North Basin (site 5) harvesting one EWM. Crew continued to work the surrounding area and swam through the native plants eventually ending in the southeast section of the bay. Crew harvested additional EWM, both single/ multi-stem, ranging from 1-5' in length.

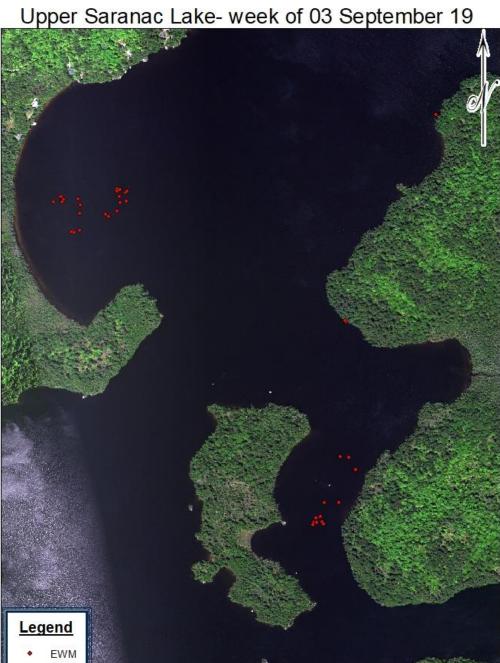
Site 10- Square bay divot- point north of Buck Island Site 11- Little Square Bay Site 12- Buck Island channel Site 13- Buck Island Bay

Crew worked site 10 from the just outside Square Bay south to the entrance of Buck Island Bay, locating two single stem EWM 0.25' and one multi-stem 2' in length.

Description: Due to early morning thunderstorms, Crew did not begin work until 11:00 am. Crew performed patterned swims through the Buck Island channel area (site 12), beginning at the southern end and worked north. Crew located mostly single stem EWM ranging from 0.5-7' in height.

Description: Crew spent the day performing patterned swims throughout Little Square Bay (site 11). Crew began in the western section of the bay and worked east throughout the" tongue." Crew located both single/ multi-stem EWM ranging from 1-8' in length.

Crew finished the day working from where they had left off in the Buck Island channel and pushed north into Buck Island Bay, working throughout native plants in the bay locating no AIS.

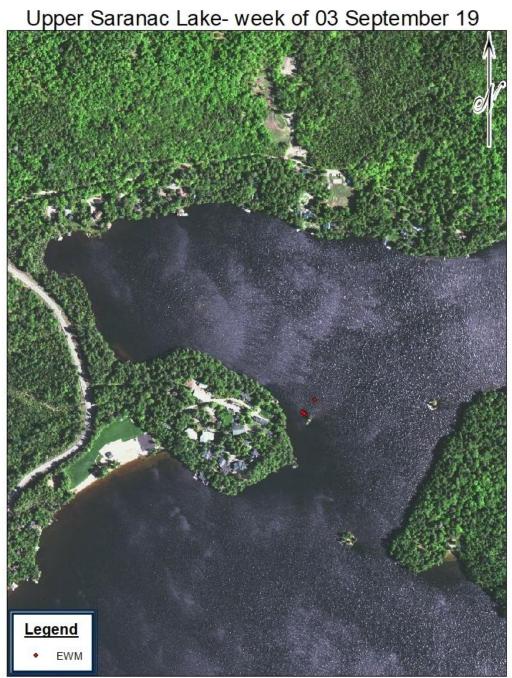
Site 23- Gilpin Bay

Crew worked the gas dock area in Gilpin Bay (site 23) locating Eurasian Watermilfoil (EWM) within the native plants north of the rockpile. EWM harvested was single/ multi-stem ranging from 0.25-6' in length.
